STONY BROOK WATERSHED MANAGEMENT PLAN

MMI #3104-01-1

September 25, 2009

MILONE & MACBROOM, INC.
99 Realty Drive
Cheshire, Connecticut 06410
(203) 271-1773
www.miloneandmacbroom.com

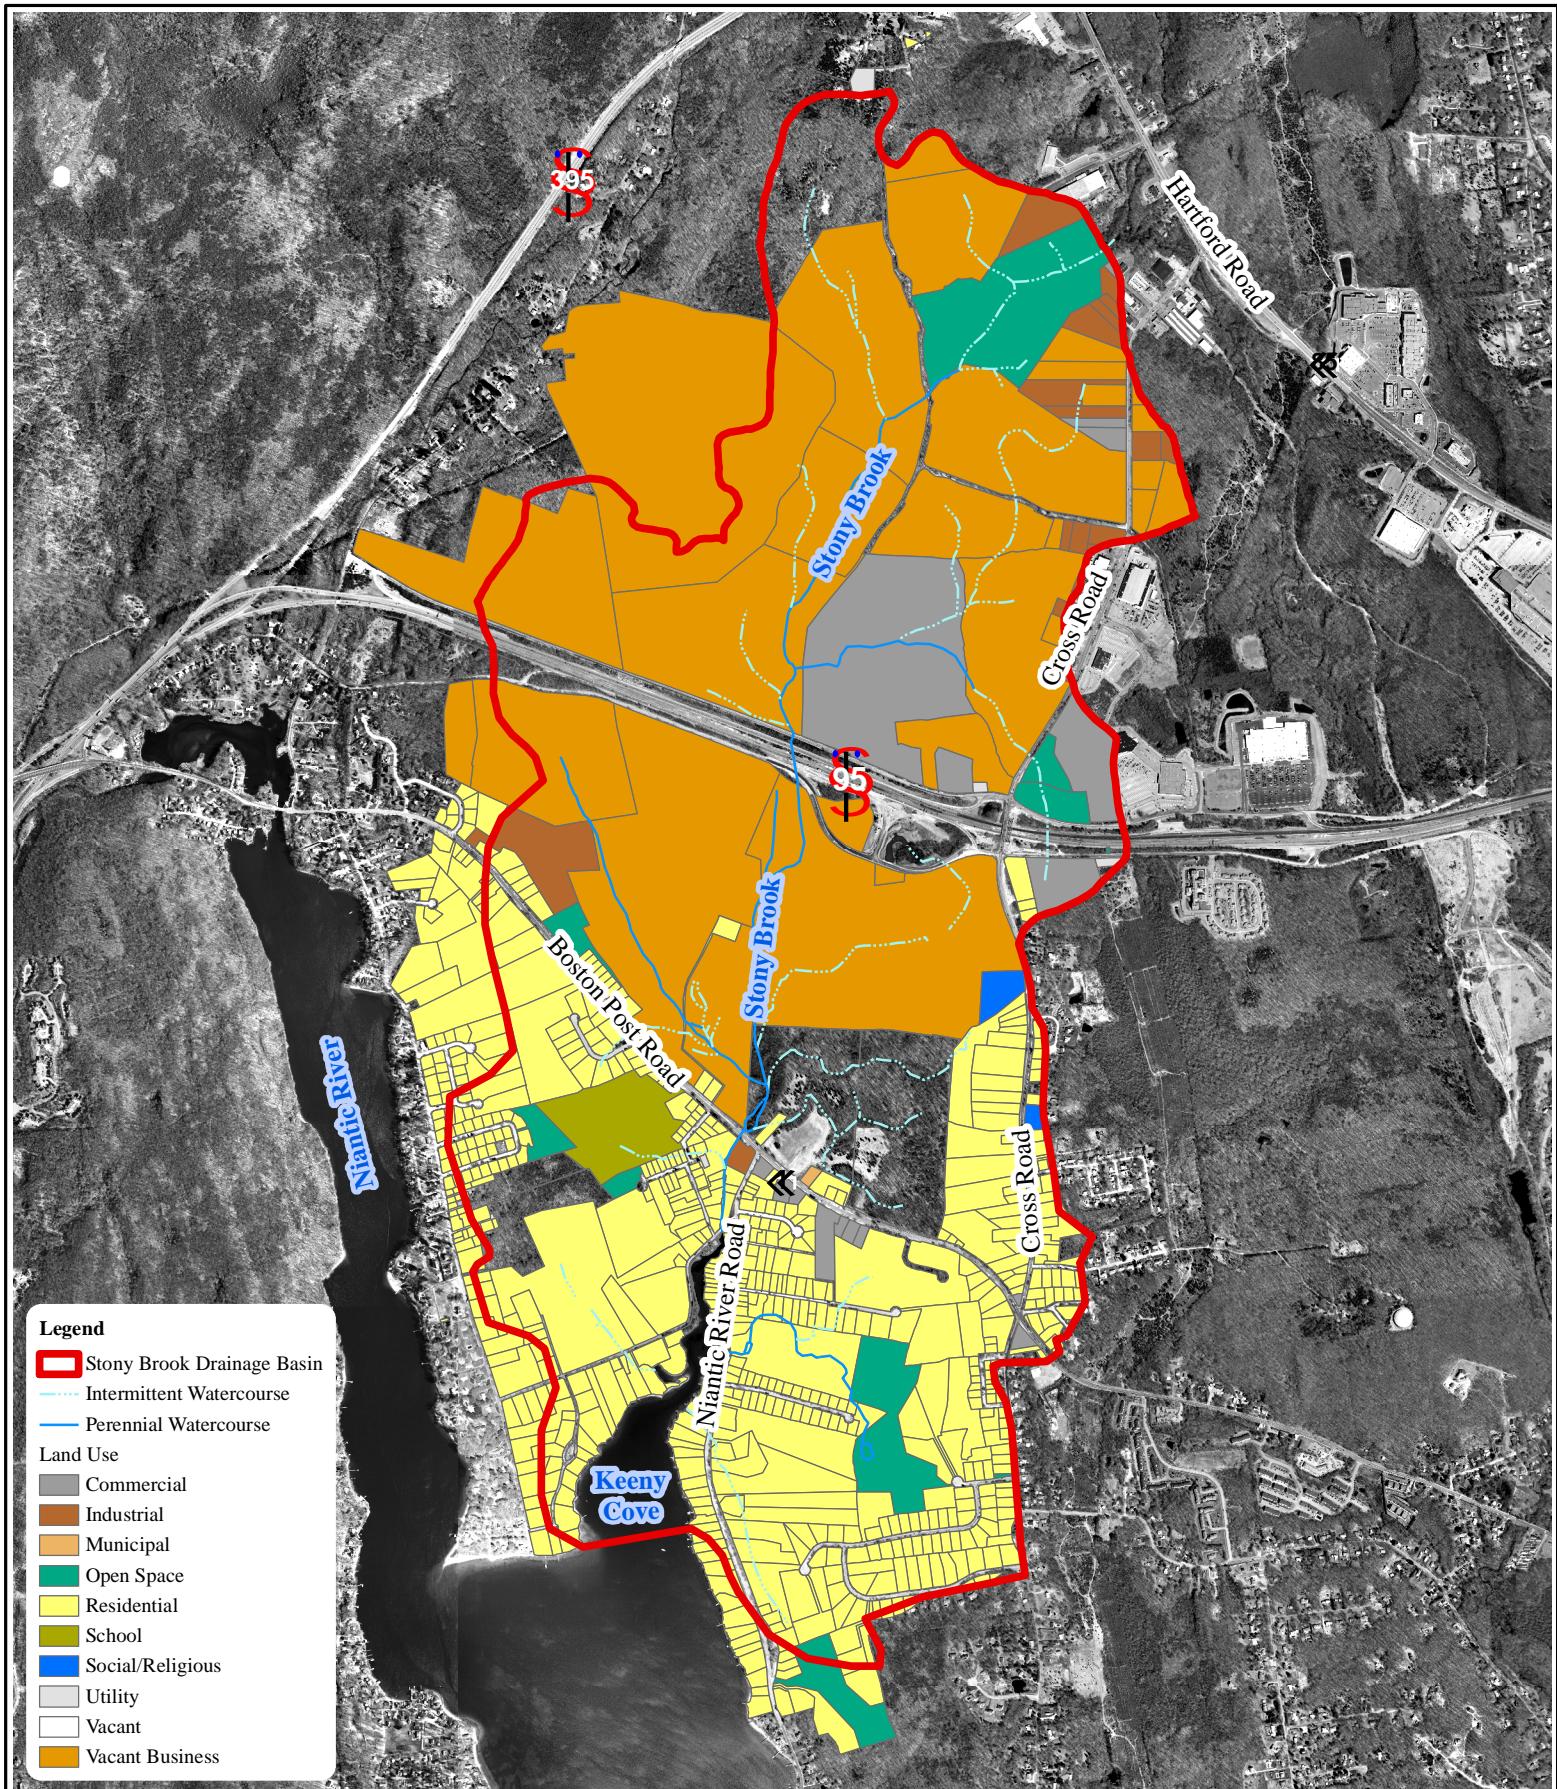
SHEET:
Figure 2-2

Land use within the Stony Brook watershed is represented on Figure 2-2. Zoning is represented on Figure 2-3. Land use and zoning within the Stony Brook watershed differs from north to south with the southern portion being dominated by residential, the central section by residential and large vacant parcels, and the northern portion dominated by undeveloped mixed hardwood forests and a few commercial properties. Commercial and industrial development are primarily located along Cross Road, I-95, and Route 1.

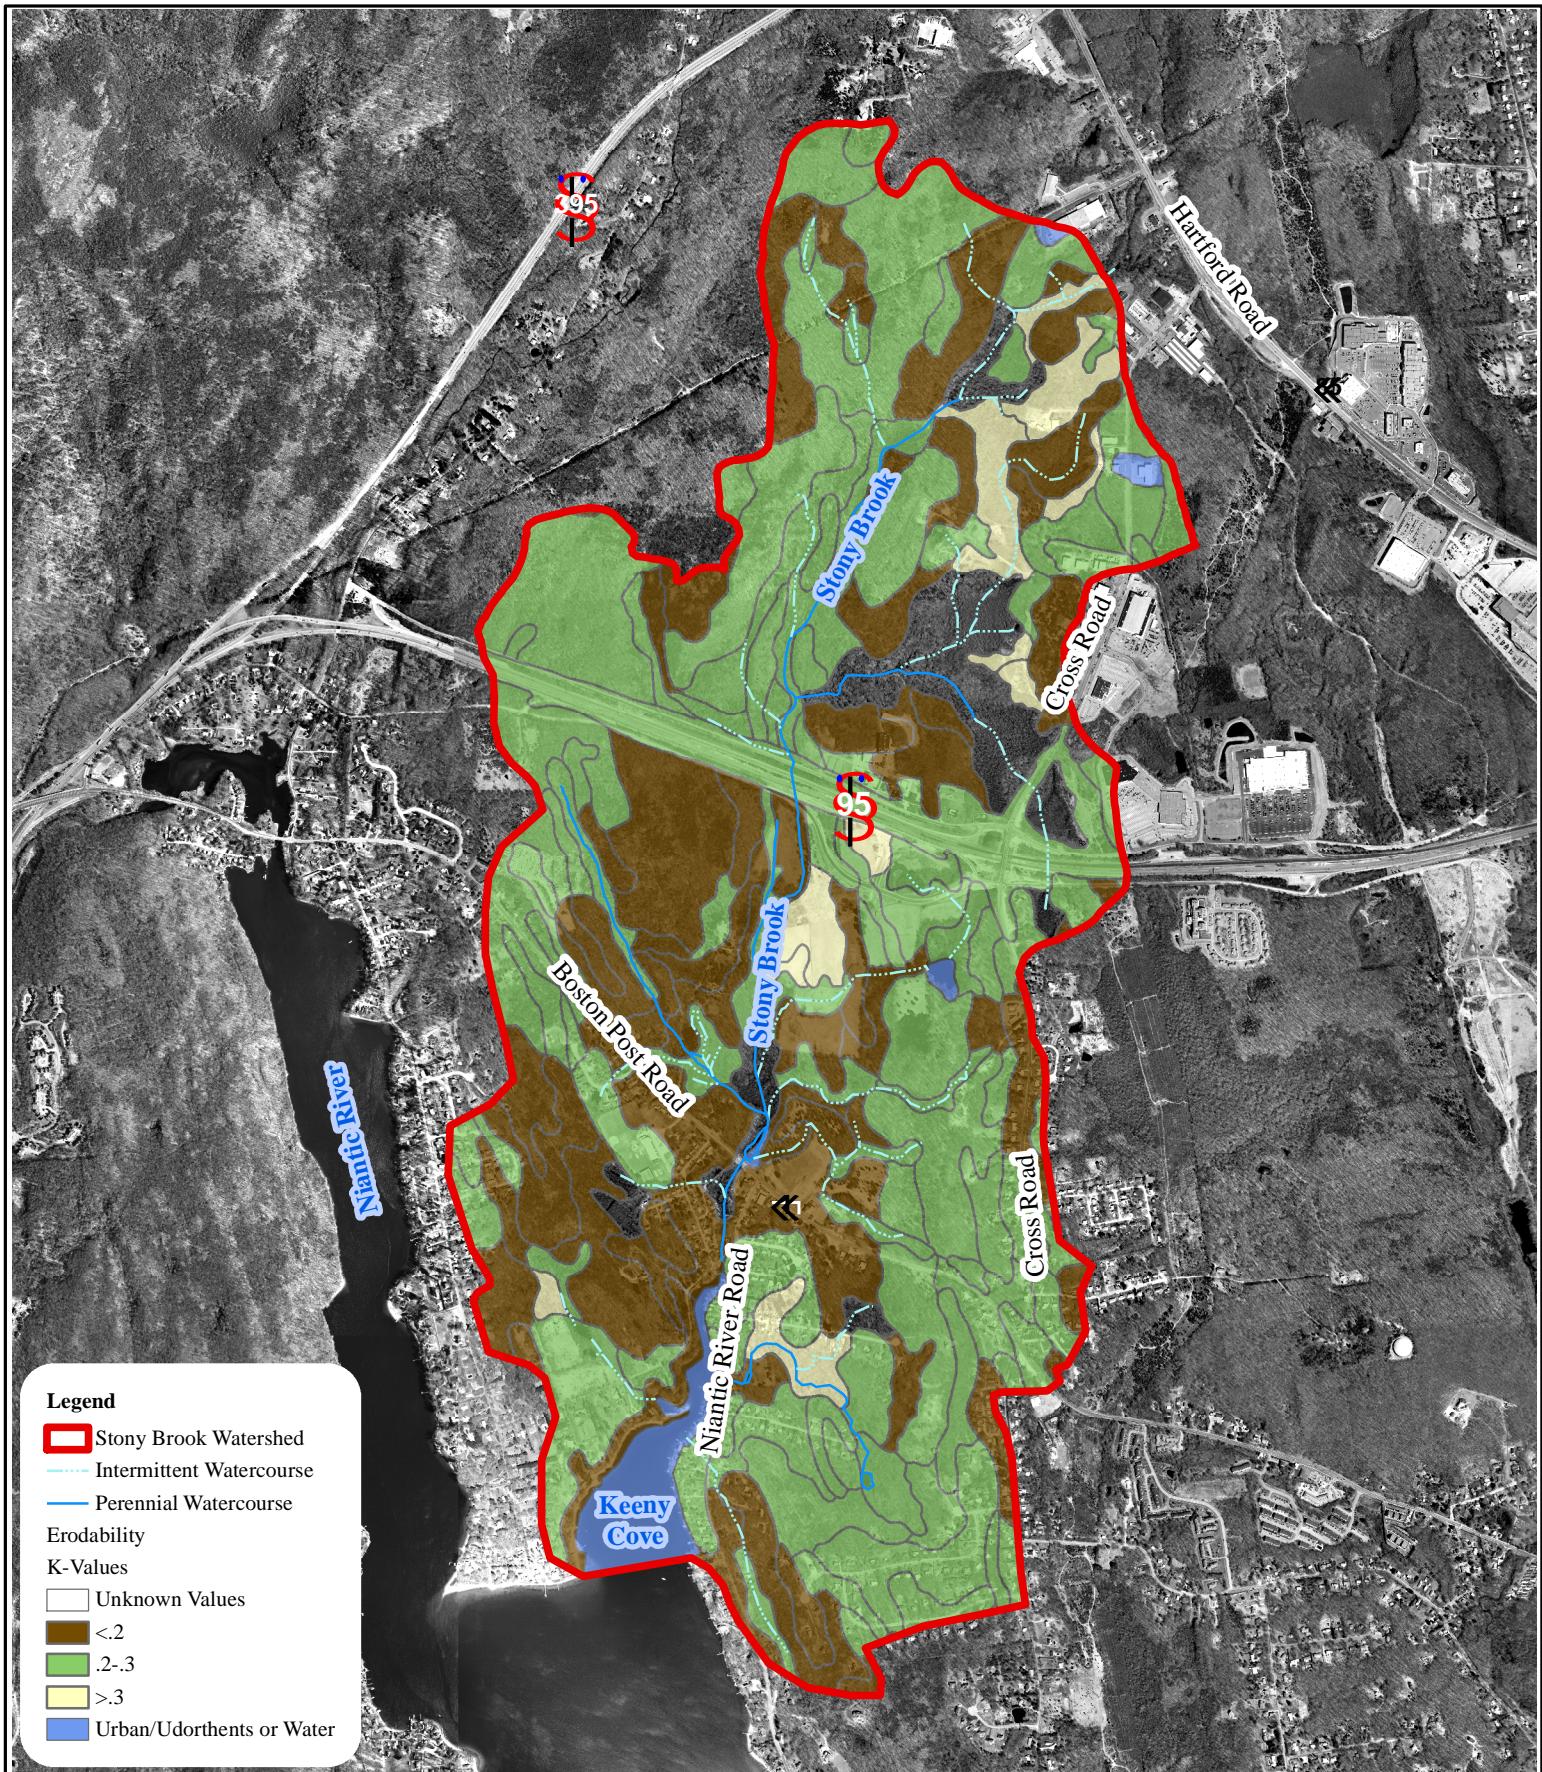
| | MMI#: 3104-01 MXD: H:soil_erode.mxd SOURCE: DEP Bulletin No.40 | 3 Stony Brook | DATE: August 2007 SCALE: 1:24,000 | SHEET: Figure 2-5 |

Determining the erodibility of a soil is important when evaluating future development projects, especially when dealing with the potential for adverse impacts to nearby wetlands and watercourses from soil erosion. Eroding soils can lead to water quality degradation and sediment deposition within nearby wetlands and watercourses.

Soil erodibility (K) is a term that has been used to describe the detachment, entrainment, and transport forces of rainfall/runoff. The K factor by definition is the soil loss from a unit plot per erosion index unit. A unit plot is defined as a 72.6-foot length of uniform nine percent slope, maintained in continuous fallow, tilled up and down hill to periodically control vegetation (Lal, 1988). The K factor is determined by identifying the geological mode of deposition, soil texture, percent organic matter, dominant soil classification, and soil permeability. The K factor is conventionally an average annual value for estimating soil loss. Several methods are available to determine the K value for a plot, including field plot studies, laboratory erosion flume studies, or soil erodibility prediction.

Soils high in clay have low K values, about 0.05 to 0.15, because they are resistant to detachment. Coarse textured soils, such as sandy soils, also have a low K value, approximately 0.05 to 0.2, even though these soils are easily detached. Medium-textured soils such as silt loam soils have moderate K-values, about 0.25 to 0.4 because they are moderately susceptible to detachment and they produce moderate amounts of runoff. Soils having high amounts of silt content are the most erodible of the soils. They are easily detached and tend to produce the highest rates of runoff. K values for these soils

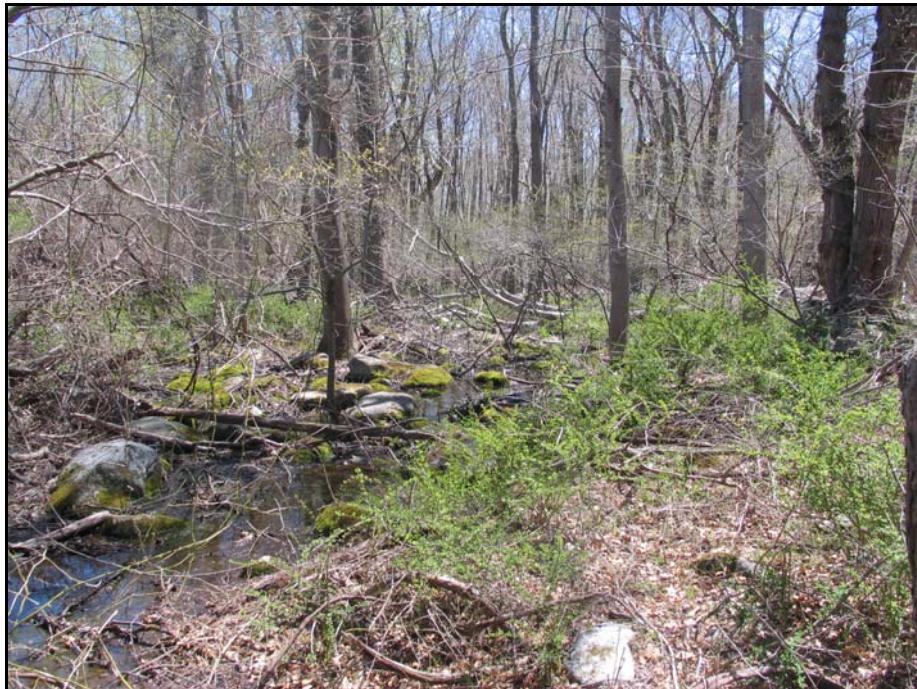
SB-90 Headwater Wetland North of Power-line

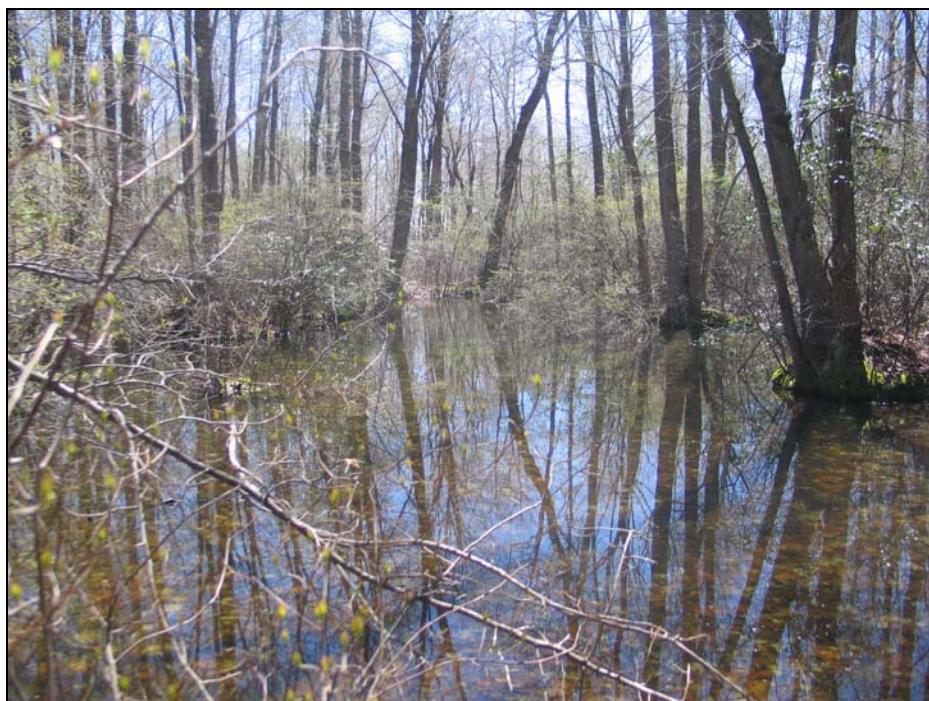
SB-90 Headwater Wetland and Vernal Pool

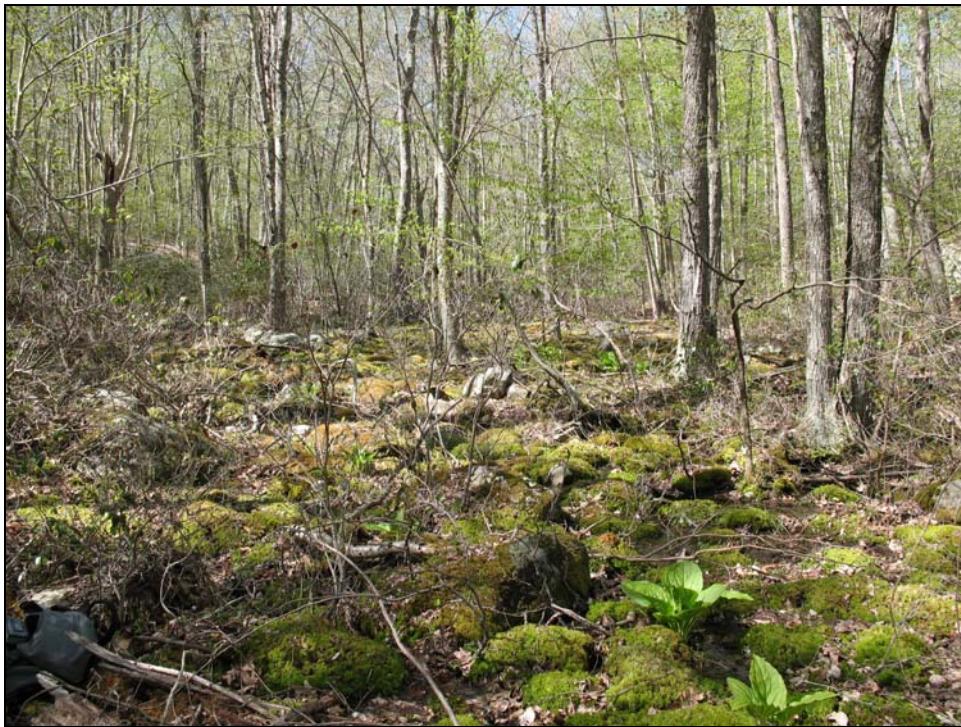
SB-80 Western Tributary & Forested Wetland

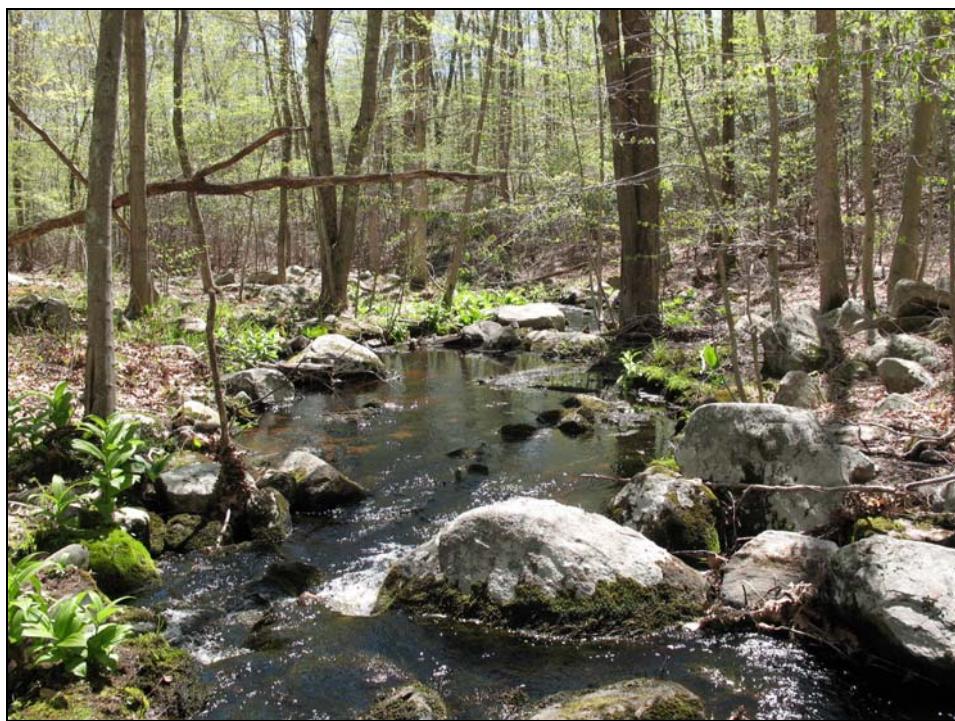
SB-80 Stony Brook Main Stem above I-95

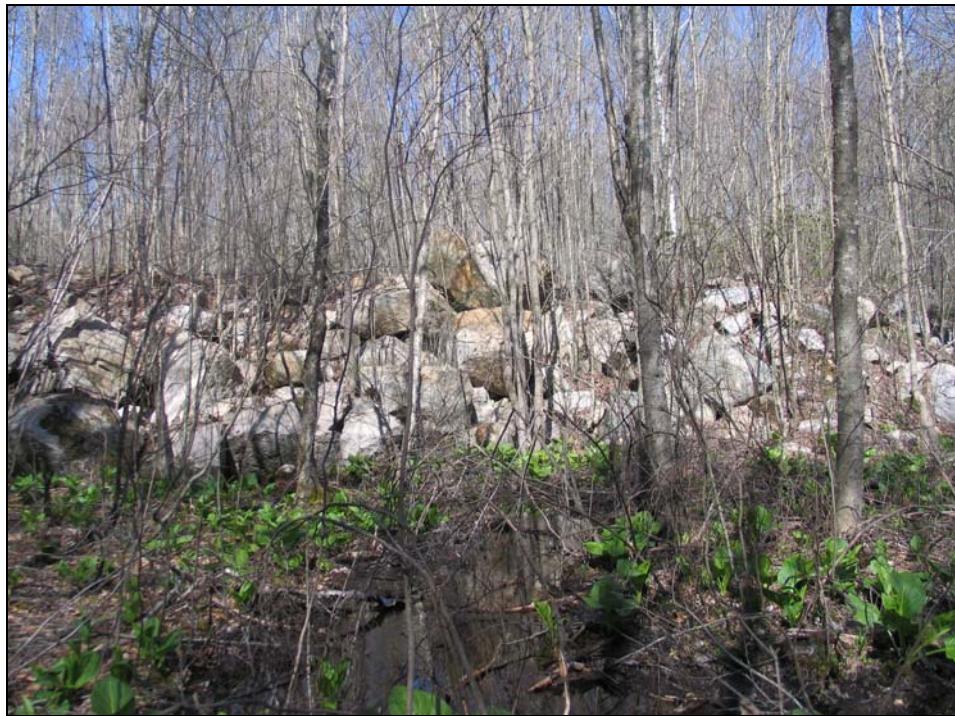
SB-70 Fill pile near headwater wetland

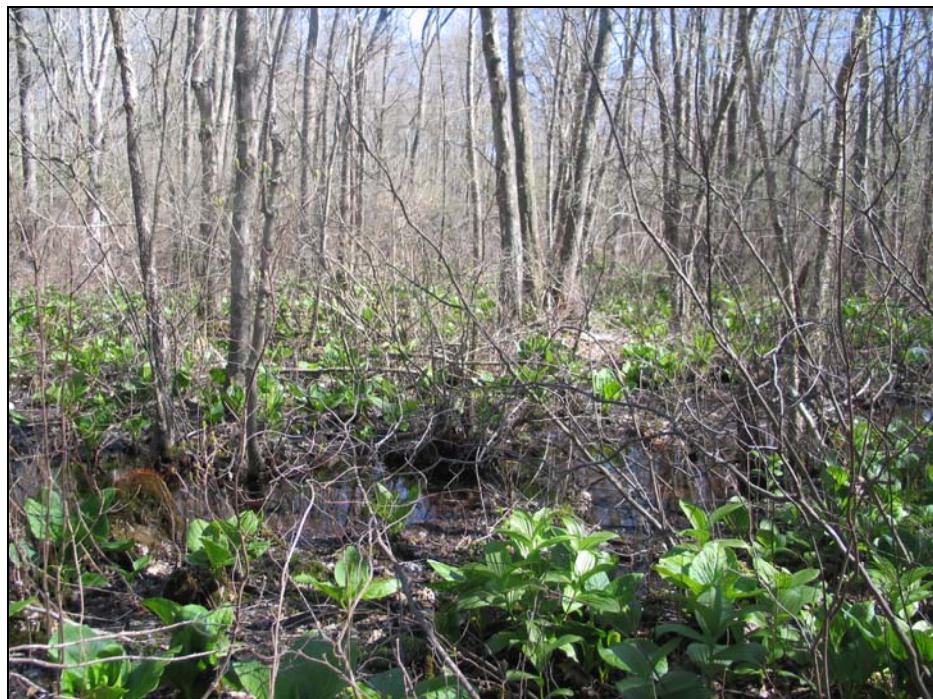
SB-70 Palustrine Forested Wetland Systems

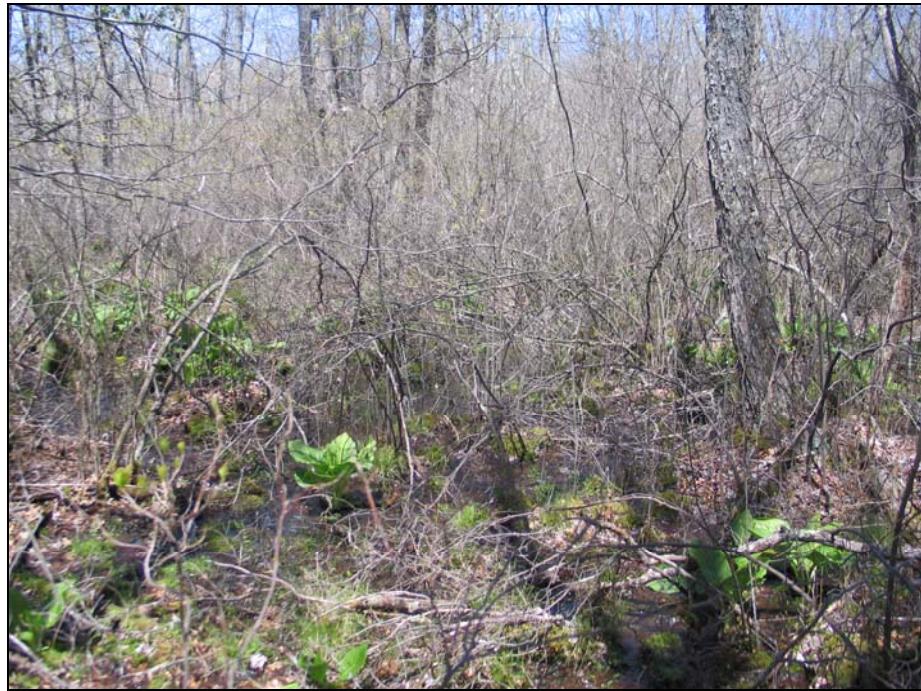
SB-70 Palustrine Scrub Shrub Wetland System

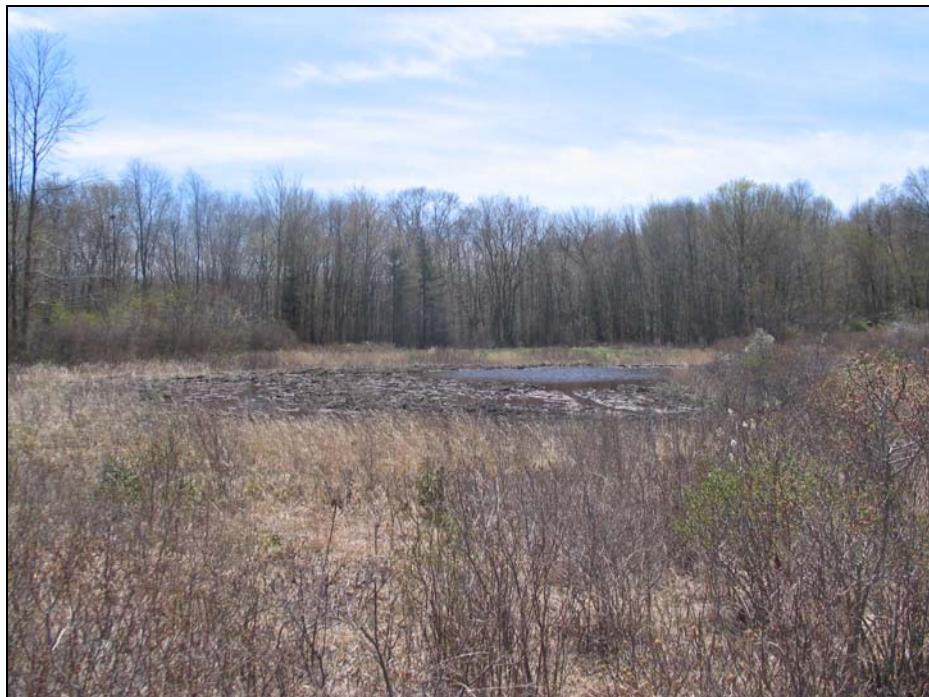
SB-70 Palustrine Scrub Shrub and Emergent Marsh at Radio Tower Parcel

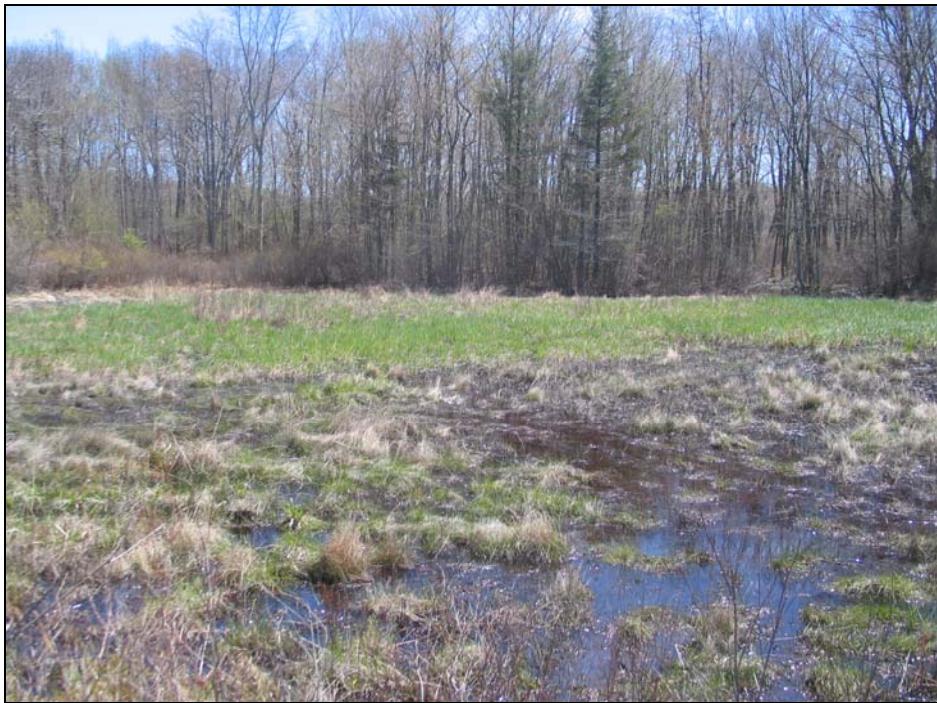
SB-70 Palustrine Wet Meadow and Emergent Marsh at Radio Tower Parcel

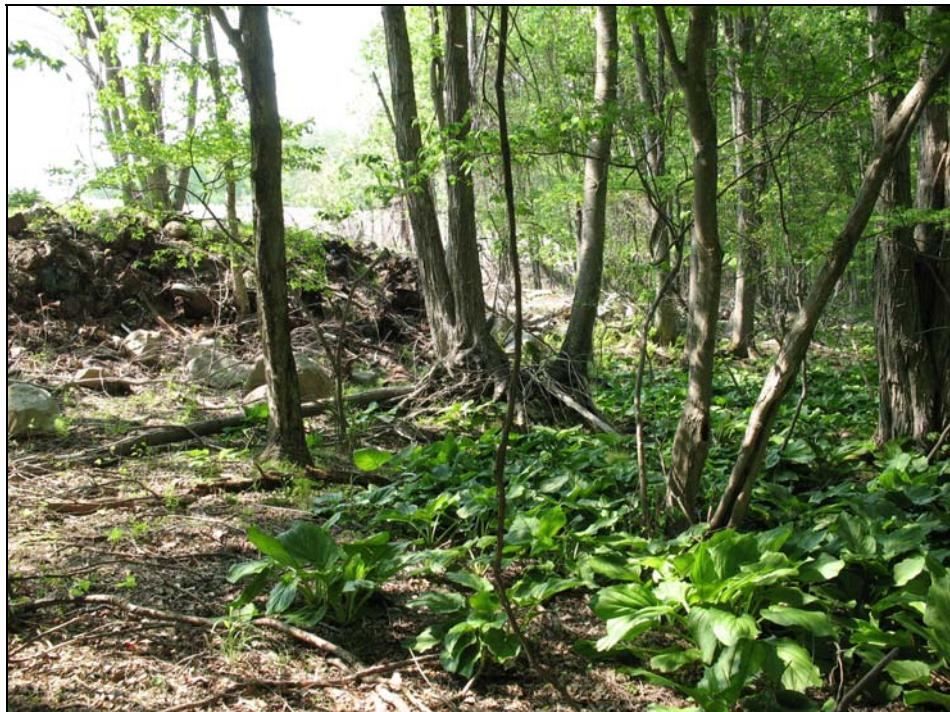
SB-60 Forested Wetlands abutting Former Auto Salvage Area

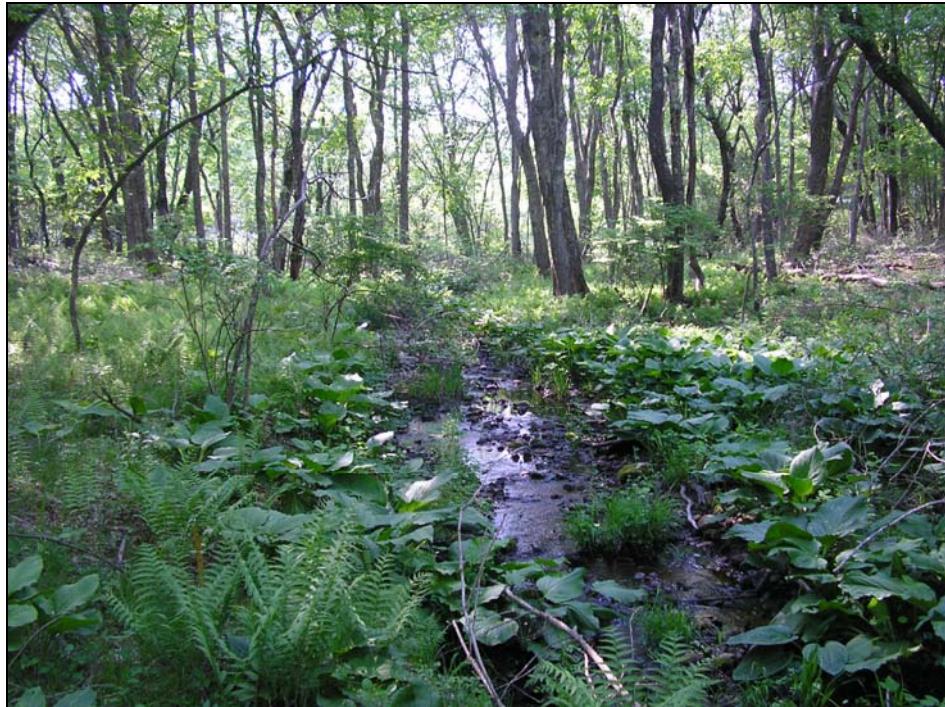
SB-60 Tributary and Forested Wetland

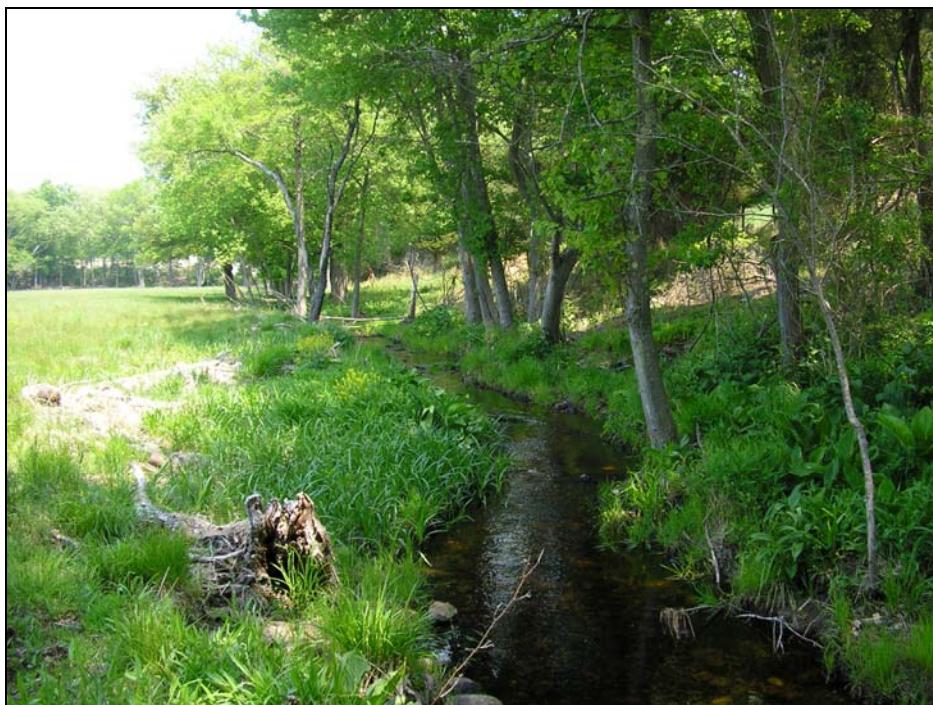
SB-50 Stony Brook Main Stem through farm fields

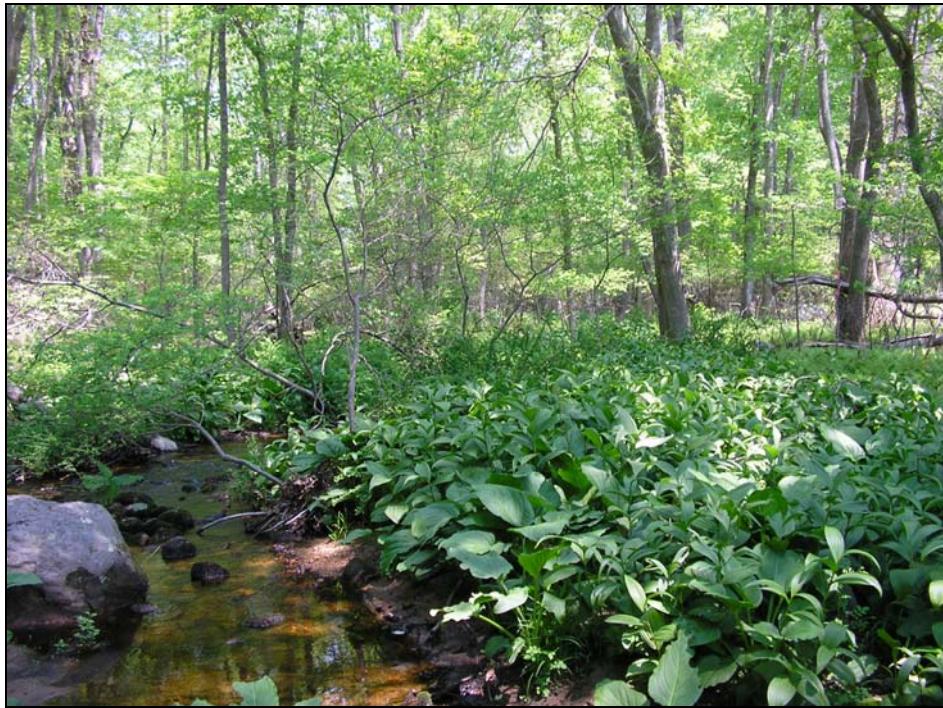
SB-50 Stony Brook Main Stem through Forested Wetlands

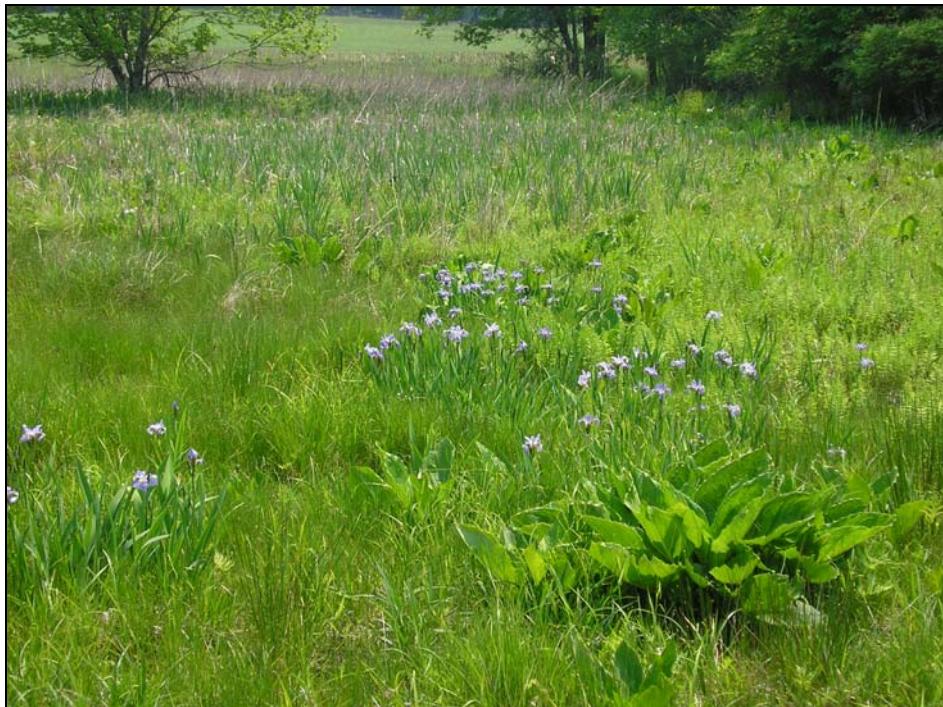
SB-50 Palustrine Wet Meadows and Emergent Marshes

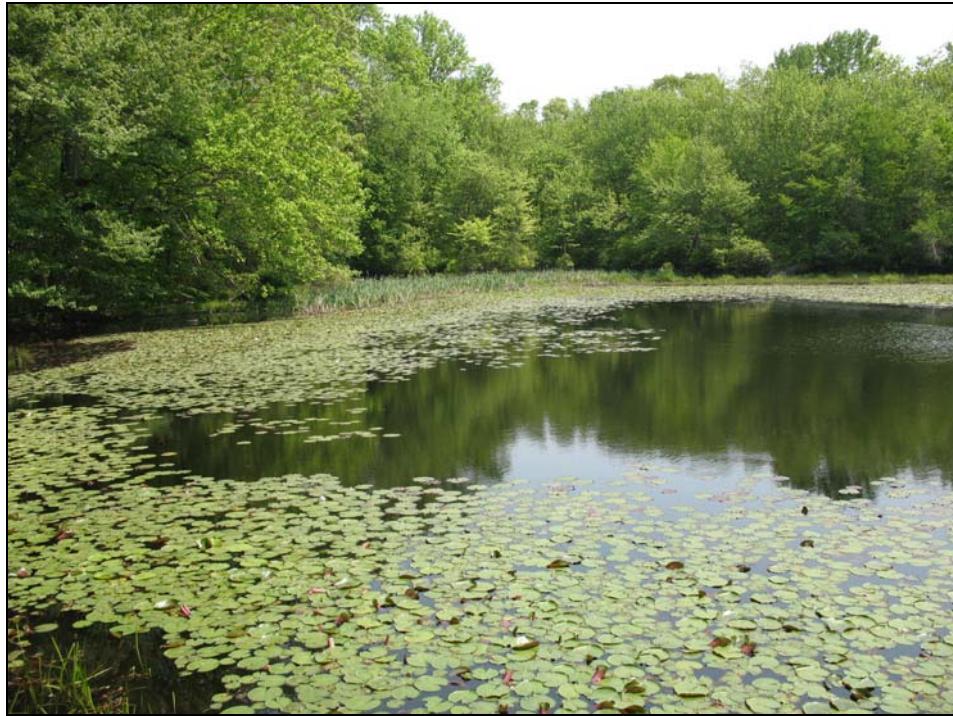
SB-50 Manmade Pond

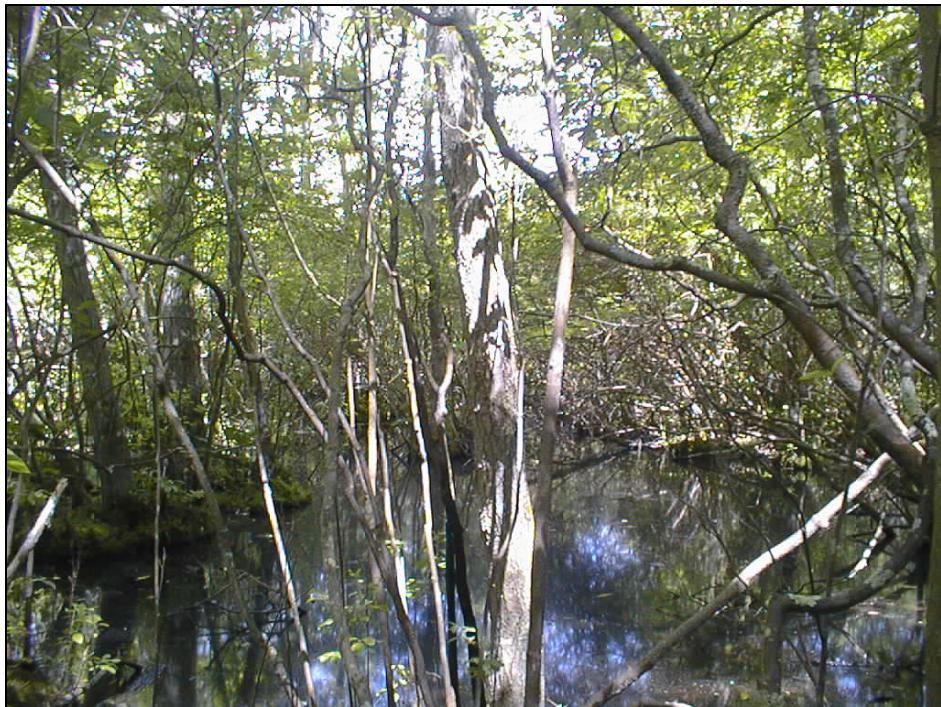
SB-40 Scrub Shrub Wetland near Stony Brook Drive

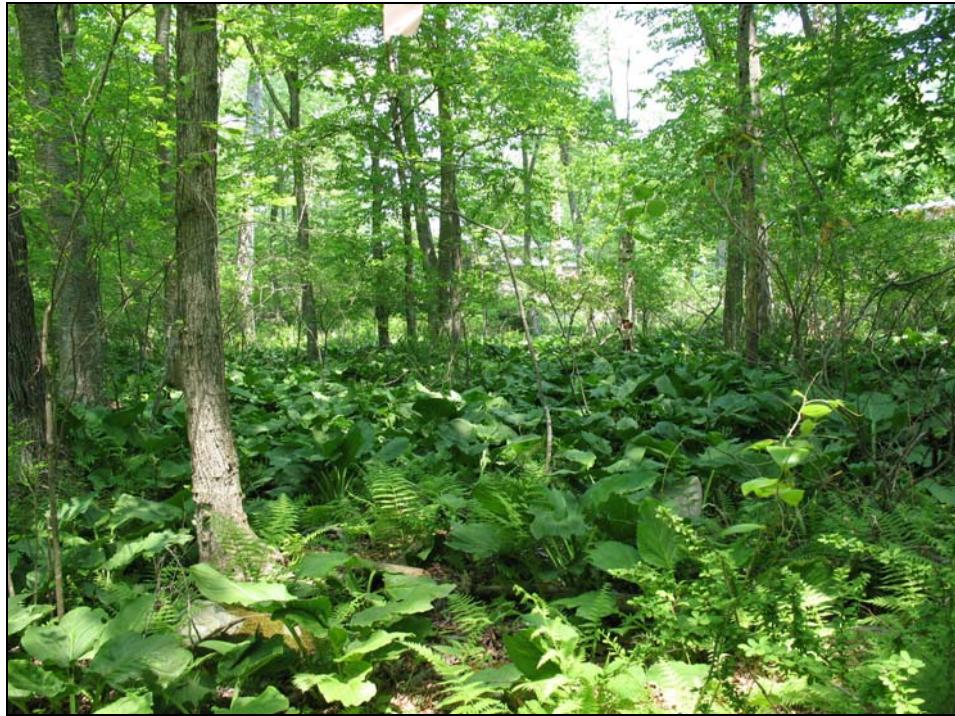
SB-40 Intermittent Watercourse and Forested Wetlands

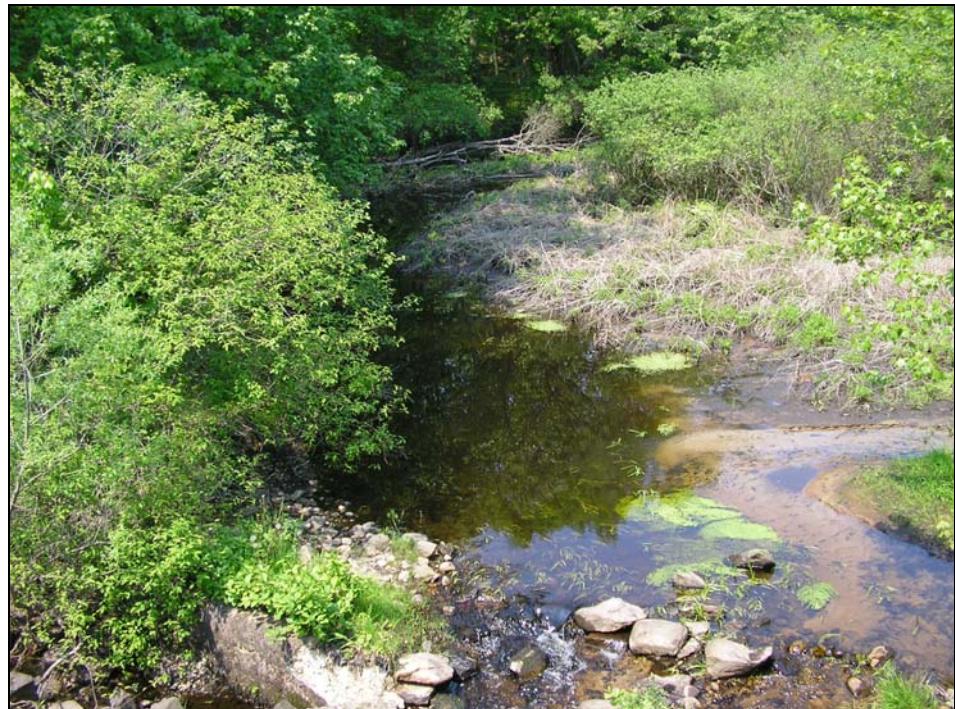
SB-40 Stony Brook Main Stem north of Route 1

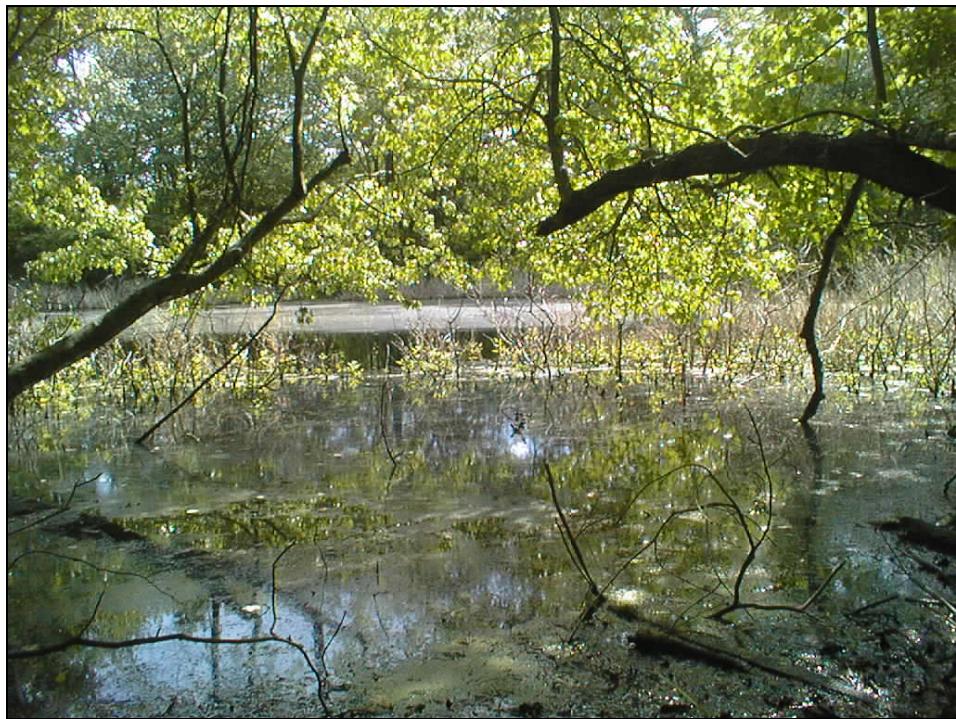
SB-30 Manmade Pond off Shawandasee Road

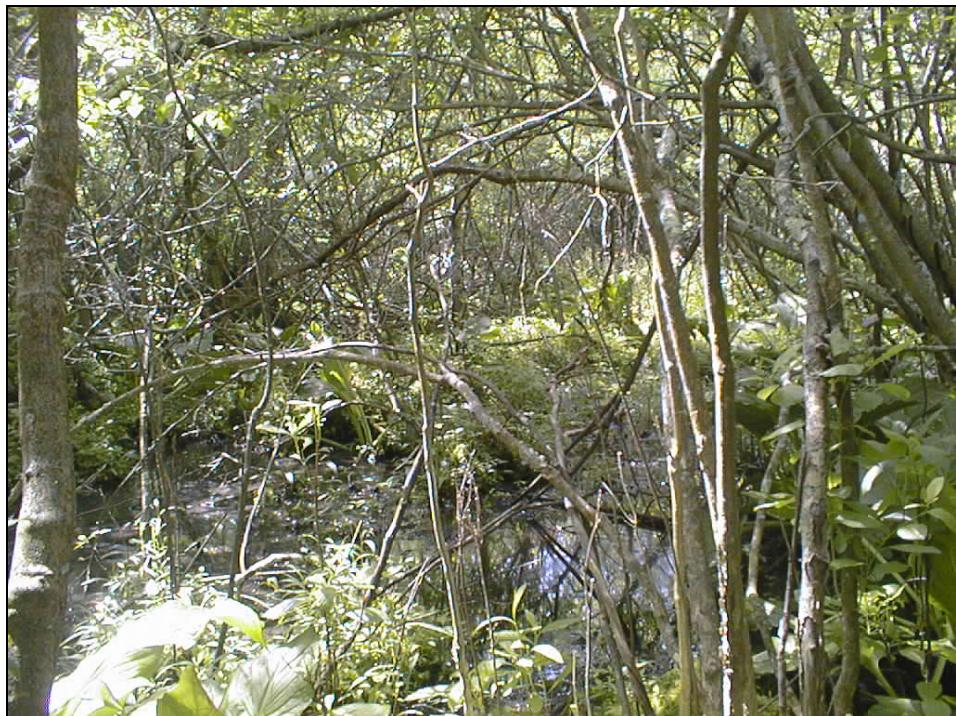
SB-30 Palustrine Scrub Shrub Wetlands

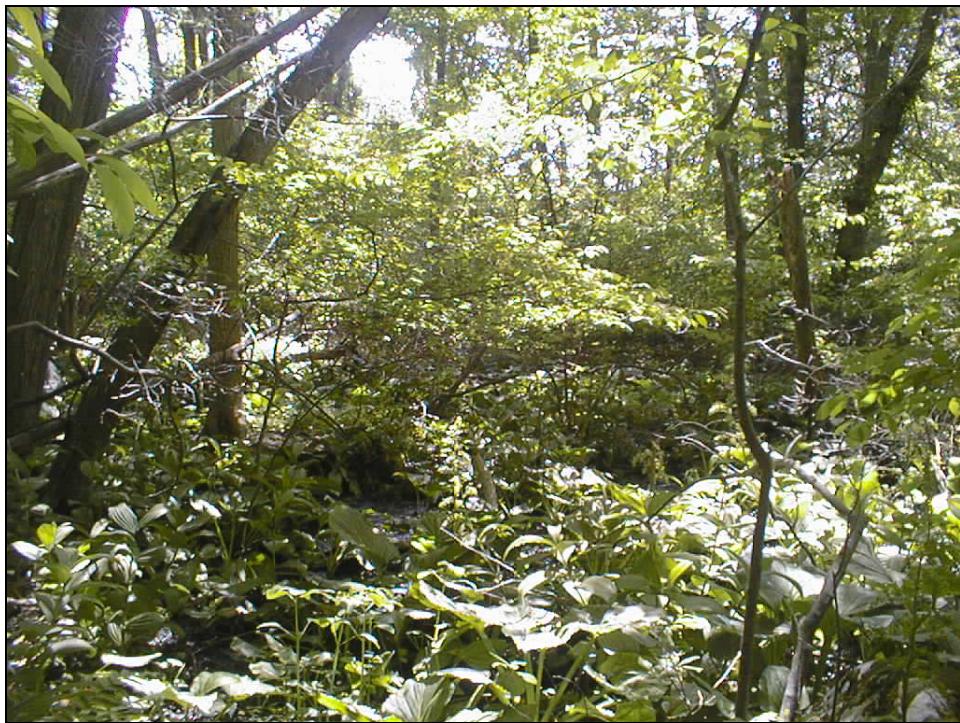
SB-20 Forested Wetlands

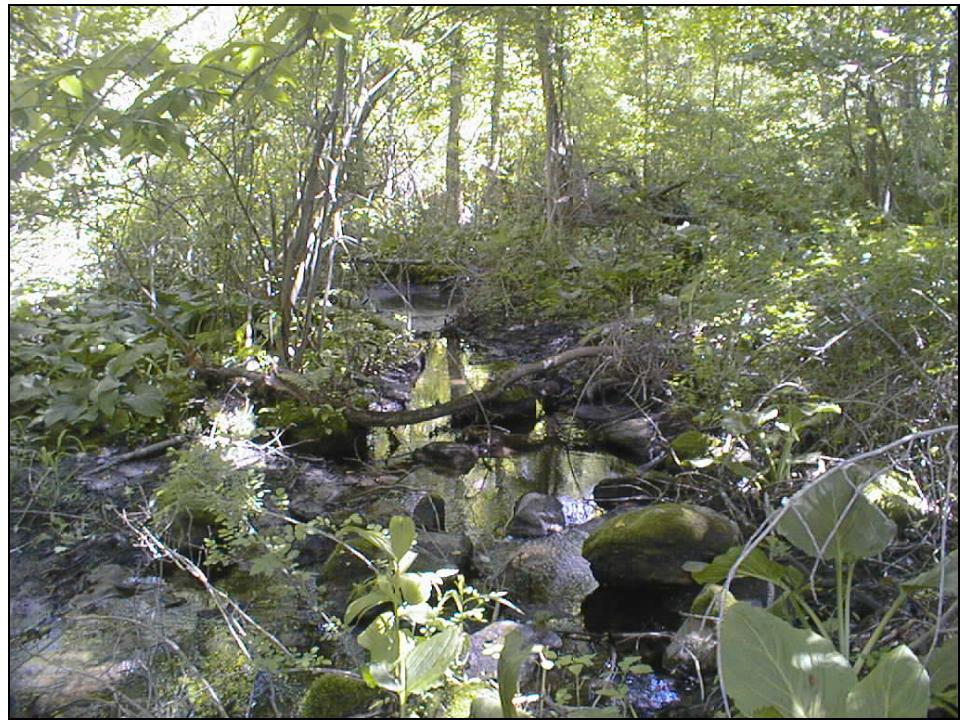
SB-20 Tributary to Keeny Cove
